# Chapter 1 I-5 Marysville Cable Barrier Evaluation

Despite the good results found across the county, the public has raised concerns about I-5 in Marysville resulting from the increasing number of crashes and the number of crossover collisions. As a result, WSDOT conducted a comprehensive review of traffic safety on I-5 through Marysville.

The purpose of this evaluation was to examine crashes that went through cable median barrier on I-5 in Marysville, so whenever practicable we included the five vehicles that crossed through cable median barrier in 2005. However, most other 2005 collision and traffic data is not yet available. As a result, some parts of this evaluation must rely upon data from 1999 through 2004.

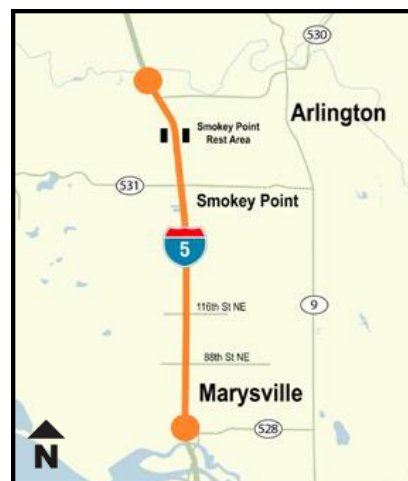
Figure 1-1  
I-5 Marysville

Crews installed 2.12 miles of median cable barrier as part of the first project in November of 1995. This barrier was located near the 116<sup>th</sup> Street interchange, between milepost 201.38 and milepost 203.70. It was located approximately 11 feet west of the northbound median edge line.

Crews installed approximately 9.08 miles of median cable barrier as part of the second project in February 2000. Crews removed the existing median cable barrier and reinstalled it closer to the bottom of the median ditch. This was done to move the barrier farther away from traffic to reduce the chance of impact with the barrier and subsequent risk of injury. It also provided a more balanced area for barrier deflection between the two directions of travel. In addition, crews installed approximately seven miles of new median cable barrier between State Route 528 and the Stillaguamish River, from milepost 199.16 to milepost 209.30.

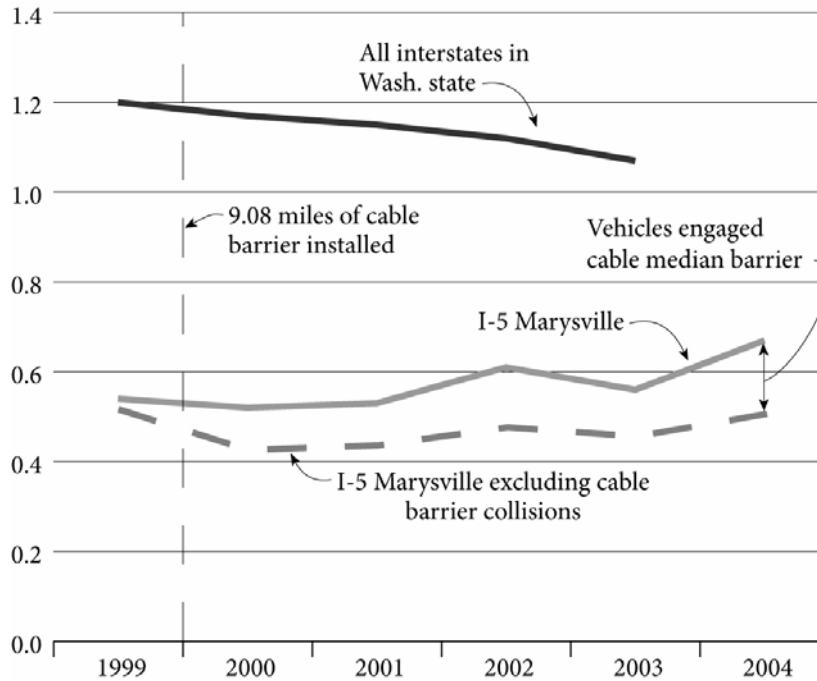
**Figure 1-2**  
**Freeway Collision Rates**

*Average collision rate per million vehicle miles (including ramps).*

This increasing collision rate is typical of freeways where traffic congestion is increasing. Speeding drivers and recently installed barrier also contribute to the increase in reported collisions.

A good way to compare highway collision data is to use collision rates per million vehicle miles traveled. This allows a fair comparison between highways that carry different volumes of traffic. This method of comparison reveals that the collision rate for I-5 in Marysville is trending upward while the rate for other interstate highways in Washington State is trending downward.

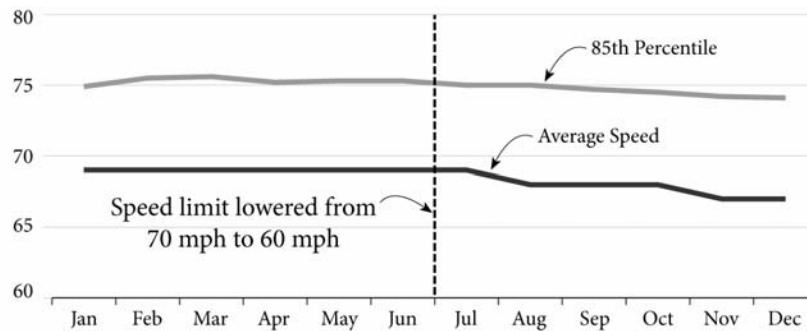
Exhibit 1-5

On July 1, 2005, WSDOT reduced the speed limit on I-5 through Marysville from 70 mph to 60 mph between just north of downtown Marysville to just north of the 172nd Street NE interchange in Smokey Point. Traffic speeds have since declined both in terms of the average as well as the speed that the preponderance of drivers travel at (85<sup>th</sup> percentile).

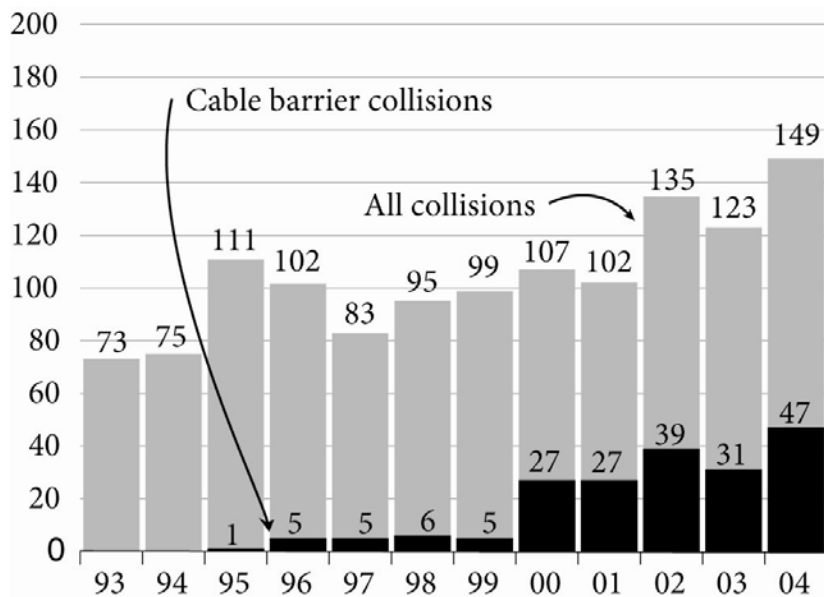
Exhibit 1-7

During the past five years the collision rate for I-5 in Marysville has increased 27 percent. If you exclude collisions with cable median barrier, the overall collision rate on I-5 in Marysville has increased 19 percent.

The increase in recorded collisions is in part due to the cable barrier installation. Before the cable barrier was installed, vehicles that went into the median and recovered were not logged as collisions. After the barrier was installed, many vehicles that went into the median struck the barrier and were subsequently logged as collisions.

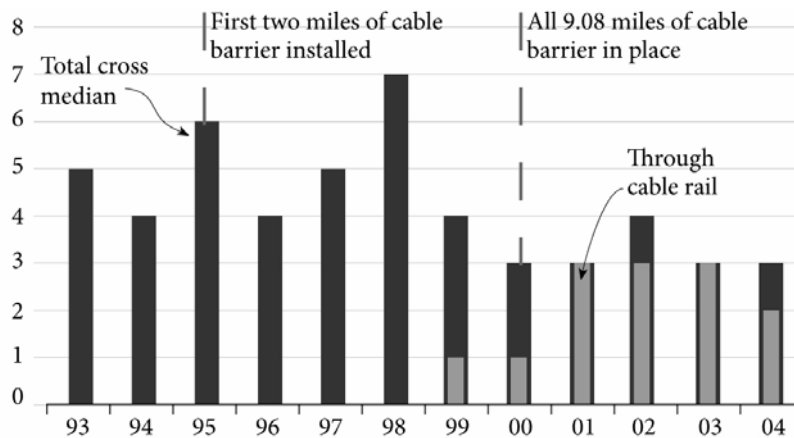
Exhibit 1-8

While more vehicles are entering the median, the total number of vehicles that have crossed the I-5 median in Marysville have declined since we installed 2.12 miles of cable median barrier in 1995 and 9.08 miles in 2000. The number of cross median collisions remains steady at three to five per year. The cable barrier is catching 92.4 percent of errant vehicles. Most of the cross median crashes since the cable barrier was installed in 2000 involved vehicles traveling through cable barrier. Five vehicles traveled through cable barrier in 2005. Total cross median collision data for 2005 is not yet available.

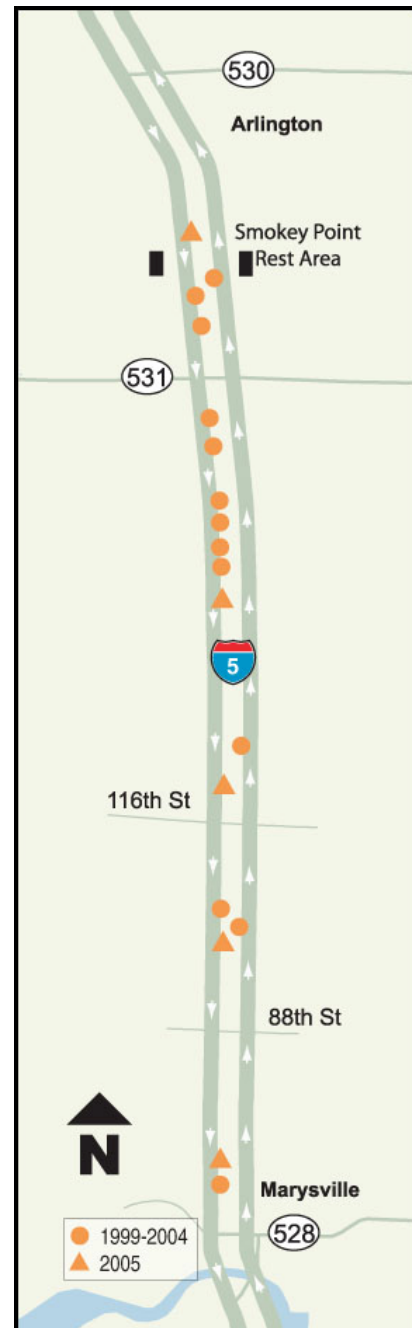
Figure 1-9  
I-5 Marysville Cross  
Median Crashes, 1999  
through 2005

On I-5 in Marysville, 171 collisions that struck cable barrier were reported to the Washington State Patrol from 1999 through 2004. Thirteen (7.6 percent) of these collisions crossed the median into the opposing lane of traffic. The rest of the state averages 5 percent.

The rate at which errant vehicles go through cable barrier in Marysville (0.11 crossovers per billion vehicle miles traveled) is higher than I-5 at Fife (0.07 crossovers per billion vehicle miles traveled) and at Vancouver (0.01 crossovers per billion vehicle miles traveled). Even though it has the lowest freeway crash rate; roughly similar traffic congestion, weather and geometric conditions, Marysville has the highest rate of vehicles hitting median barrier and the highest cross median crash rate.

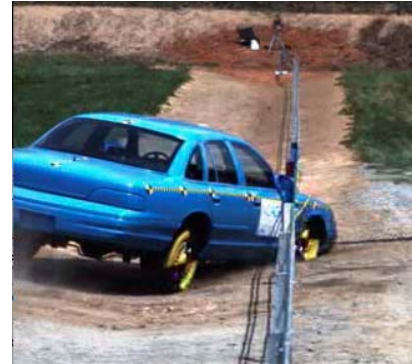
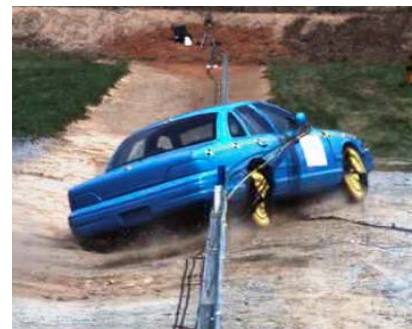
**Exhibit 1-10**  
**Car Lifting Cable Barrier**

*This photo, from a Federal Highway Administration crash test, shows how the front tires of a sedan compress after hitting the bottom of a ditch. This allows the bumper of the car to nudge under the lowest barrier cable.*

*As the vehicle continues forward it lifts the cable median barrier and continues up the slope, while the cables pass over the top of the vehicle.*

This data, along with collision and maintenance reports, overwhelmingly suggest that southbound sedans ran into the median and bottomed out in the ditch. This compressed the cars' front tires, which left their front bumpers low enough to nudge beneath the lowest cable on the barrier. As momentum carried the cars up the slope, they lifted the cable median barrier and continued across the median as the cables passed over the top of the vehicle. This accounts for a preponderance of the cross median collisions near Marysville.

In 2006, WSDOT will install a second run of cable barrier in the I-5 median in Marysville. We decided to add a second run of cable barrier because it should reduce the risk of serious injury to people in vehicles that hit it compared to the other alternatives while also stopping vehicles from crossing through the barrier into oncoming traffic. We evaluated a broad array of options, including concrete barrier and guardrail in multiple configurations. These options would increase the number and severity of crashes overall (for more information regarding injuries involved with different barrier types, see Chapter 2).

The new high tension cable barrier will be closer to the southbound shoulder, approximately twelve feet from the fog stripe on the opposite side of the median from the current cable barrier. It will deflect less than the current cable barrier. Because errant vehicles in both the southbound and northbound directions will engage a cable barrier before running into the bottom of the median ditch, this should significantly reduce and perhaps eliminate the possibility that vehicles could go under the cable barrier since they will already have engaged the cable barrier before bottoming out in the ditch. It should also control the risk of collisions due to the cable deflecting cars into oncoming traffic lanes. Also, as part of the new project, all locations where the median slopes are currently steeper than 6H:1V will be modified to provide a flatter slope.

Placing cable barrier on both sides of the median ditch provides a redundant system to control the chance of cross median collisions.

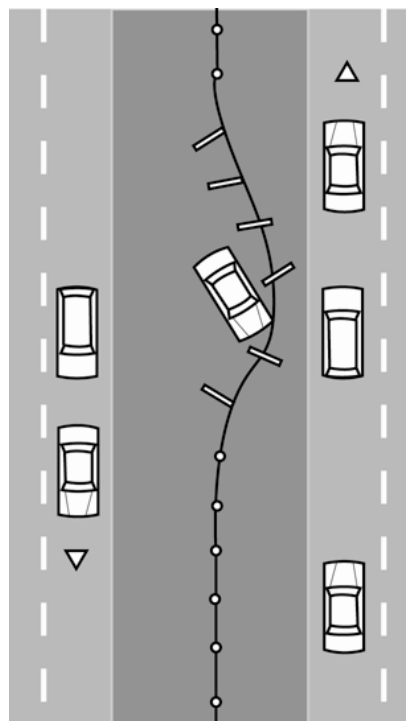
**Figure 1-12**  
**Cable Barrier Deflecting During Impact**

There were also instances where the cable rail exceeded the deflection needed to contain the vehicle in the median, however the cables still caught the vehicle. In these cases the vehicle encroached partially into the oncoming lane. From 1999 through 2005, three of 18 cross cable rail crashes involved cable rail acting in this manner, and in all of these instances the cable barrier still prevented a more serious head on collision from occurring. Many of the collisions involved extremely high speeds and angles of collision.

*Cable barrier is designed to flex and absorb the force of impact when struck while still keeping an errant vehicle within the median.*
